WBV - 90

GIWW WEST CLOSURE COMPLEX - PUMP STATION

Inspection Report

Date: 5/27/2011 **Start Time:** 6:00 AM **End Time:** 1:00 PM

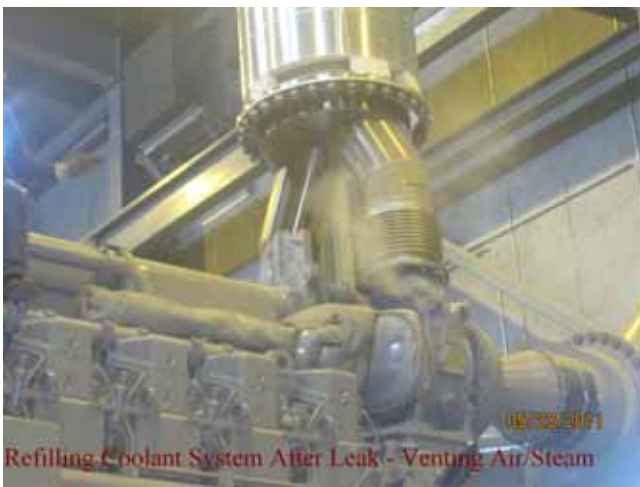
Refilling Coolant System After Leak - Venting Air/Steam

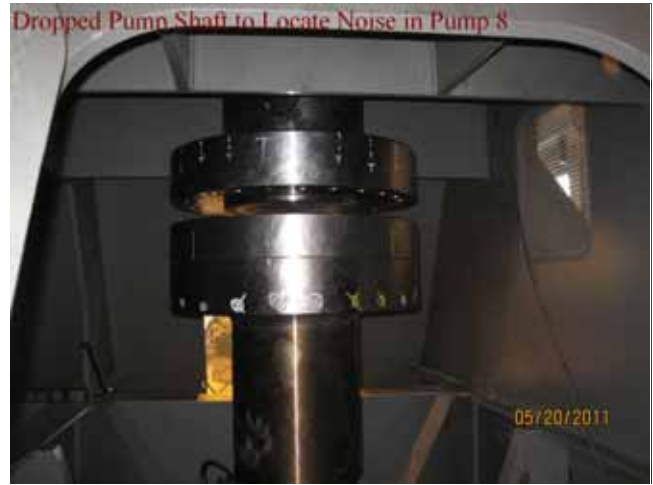
Dropped Pump Shaft to Locate Noise in Pump 8

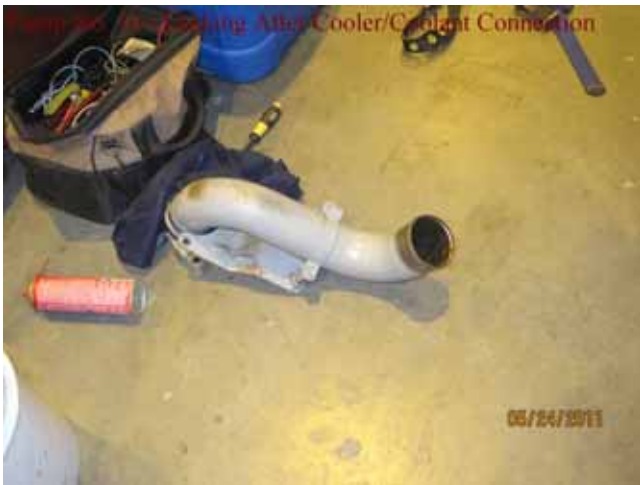
Leaking After Cooler/Coolant Connection
