WBV - 90

GIWW WEST CLOSURE COMPLEX - PUMP STATION

Inspection Report

Date: 5/27/2011 **Start Time:** 6:00 AM **End Time:** 1:00 PM

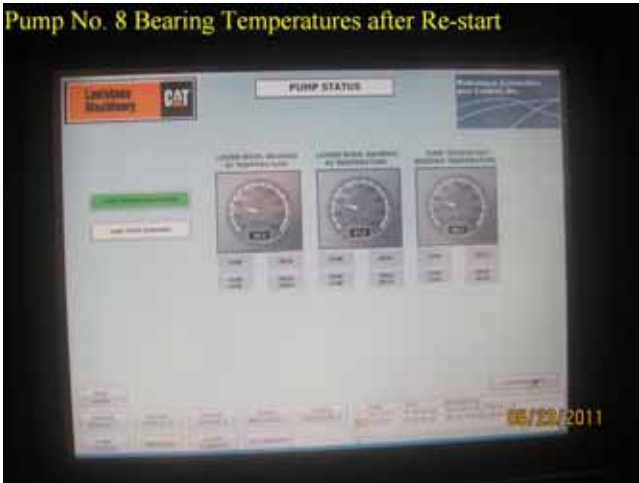
Pump No. 8 Operating

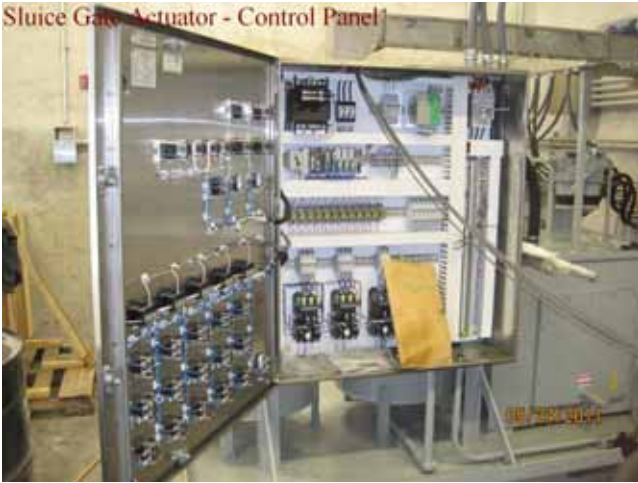
Sluice Gate Actuator - Control Panel
