WBV - 90

GIWW WEST CLOSURE COMPLEX - PUMP STATION

Inspection Report

Date: 5/27/2011 **Start Time:** 6:00 AM **End Time:** 1:00 PM

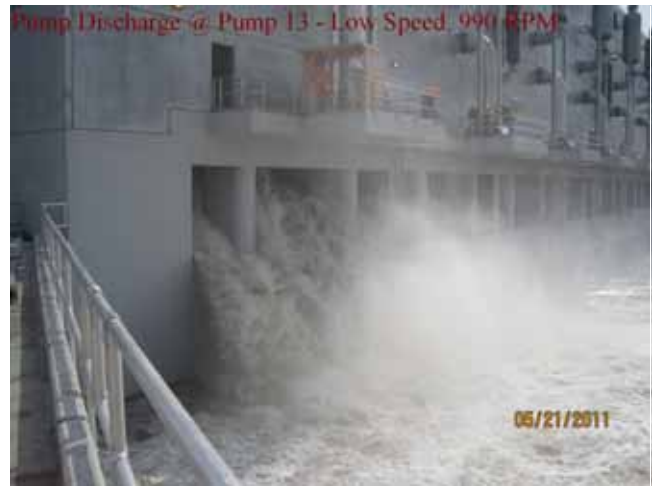
The flow of water into the intake of the pump appears to be very gentle with no indication of vortices that would cause any flow conditions that are detrimental to long term pump life. While pumping at the 990 rpm engine speed (low speed), the trash rake cleaners were tested and little debris was collected. Most pumps were tested without the screen cleaners operating and intake head losses through the screen rarely exceeded 0.3 feet.

Pump Discharge @ Pump 13 - Low Speed 990 RPM

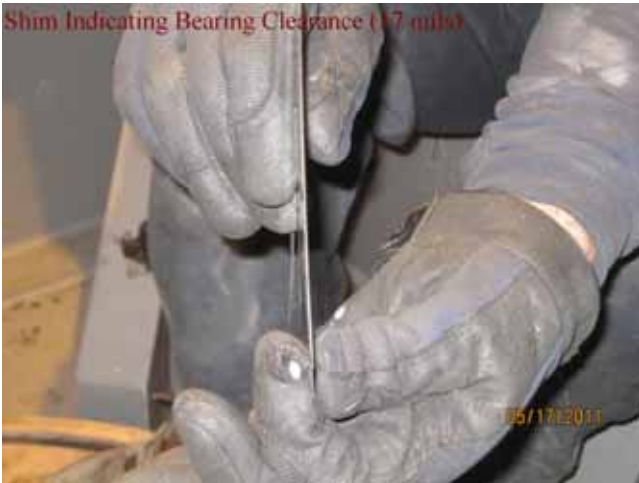
Shim Indicating Bearing Clearance (17 mils)

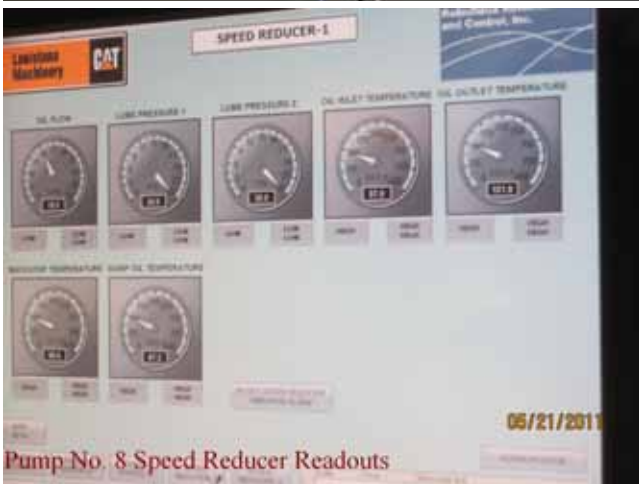
Pump No. 8 Speed Reducer Readouts

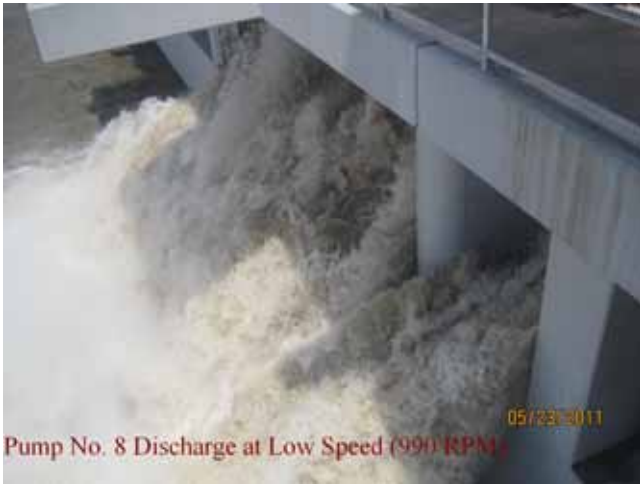
Pump No. 8 Discharge at Low Speed (990 RPM)

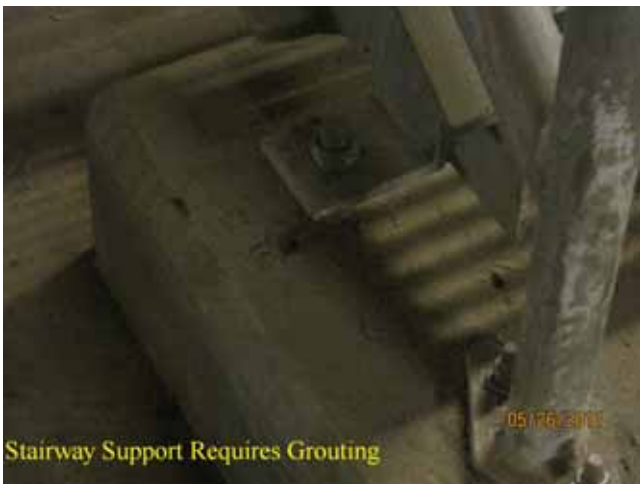
Stairway Support Requires Grouting

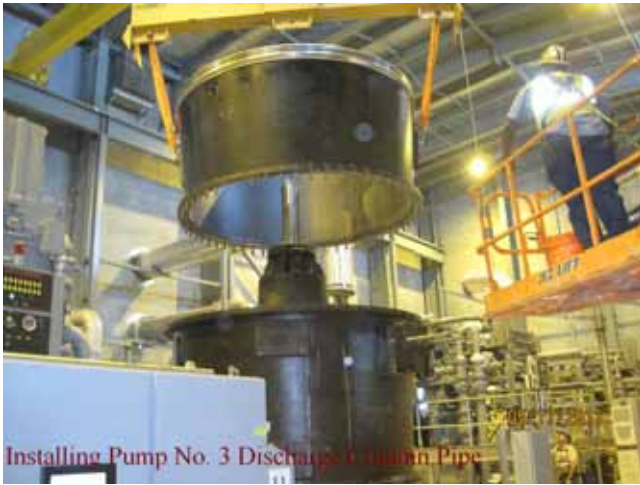
Installing Pump No. 3 Discharge Column Pipe

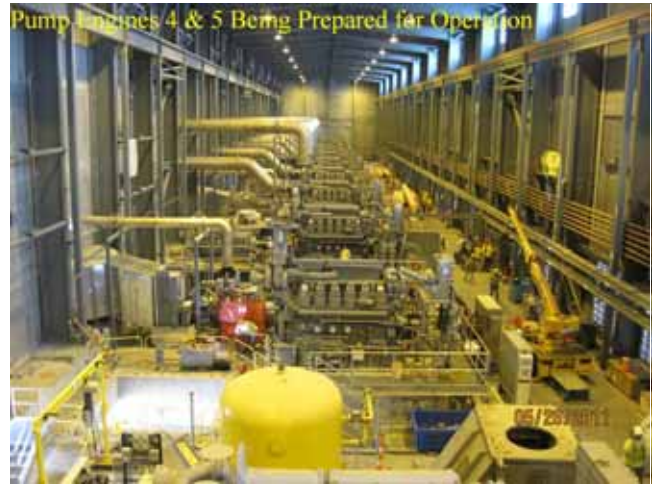
Pump Engines 4 & 5 Being Prepared for Operation

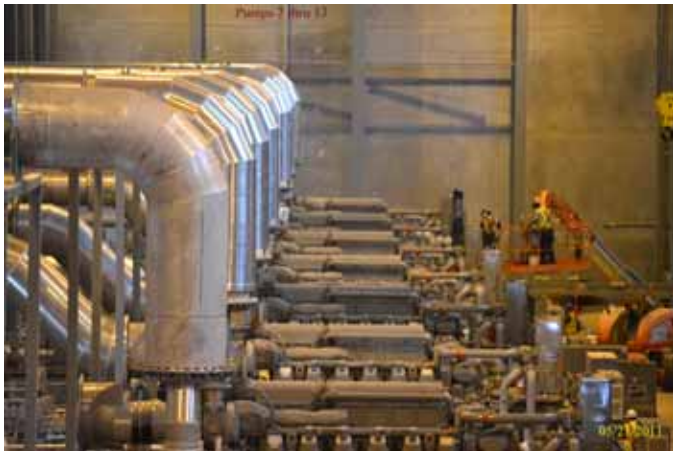
Pumps 7 thru 13

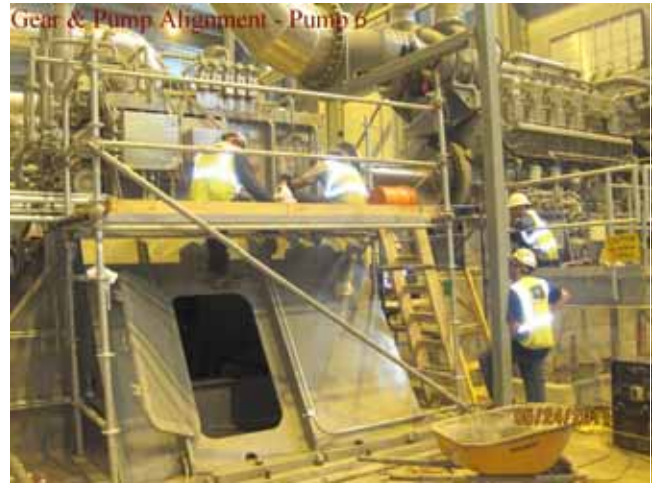
Gear & Pump Alignment - Pump 6

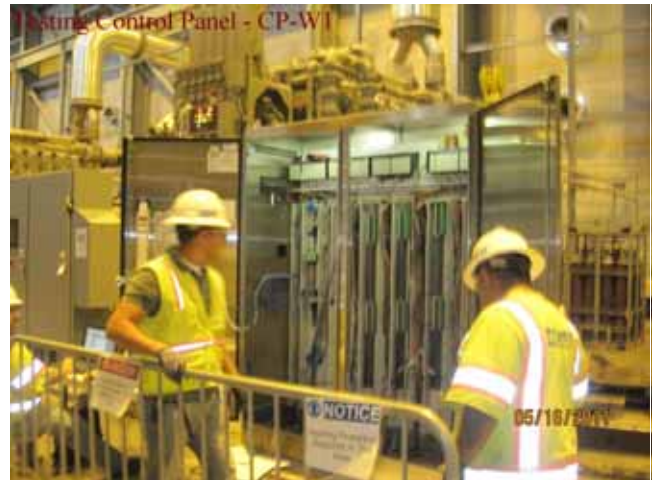
Testing Control Panel - CP-W1

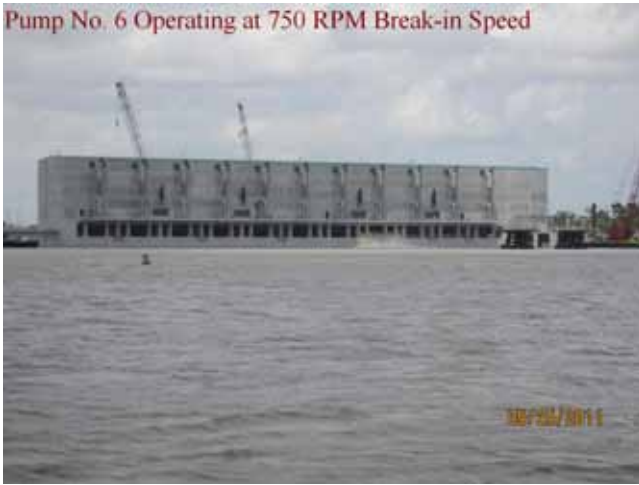
Pump No. 6 Operating at 750 RPM Break-in Speed

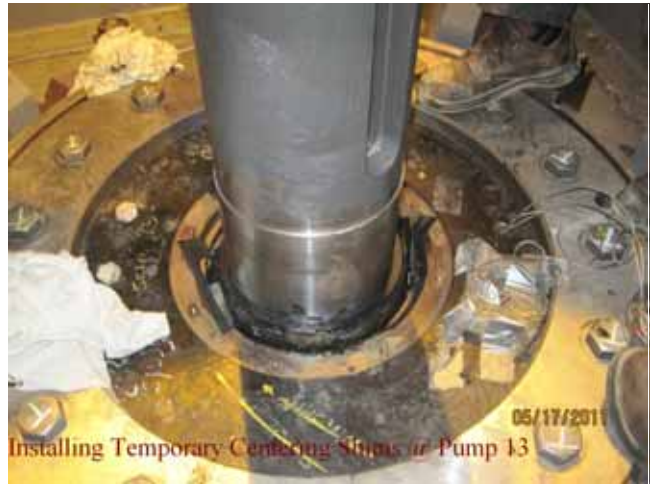
Installing Temporary Centering Straps on Pump 13

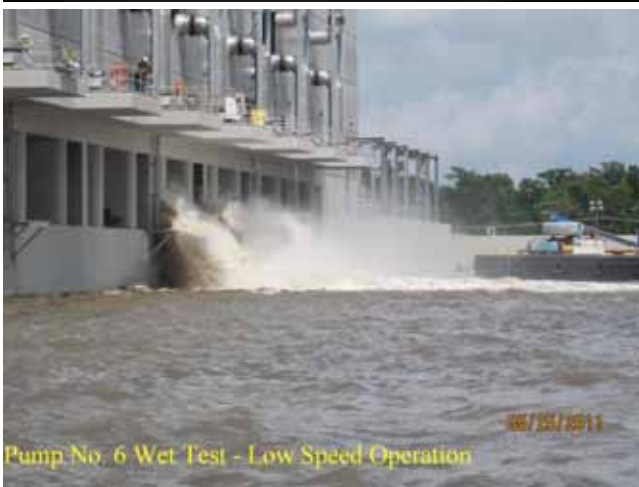
Pump No. 6 Wet Test - Low Speed Operation

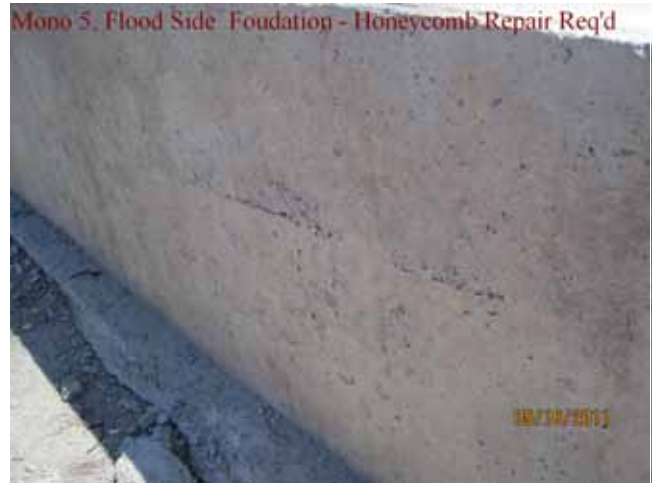
Mono 5, Flood Side Foudation - Honeycomb Repair Req'd
